Manhole Inspection Summary

Manhole # S11O__028MH

Insp Date: **4/16/08 1:50 PM**

Location Address: **3220 Frederick Ave**

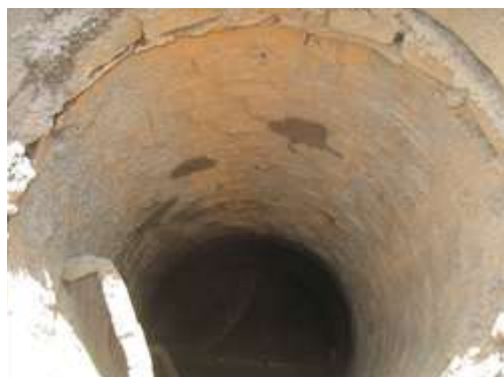
Defect 3

Condition: ☐ Sound ☐ Cracked ☐ Root Intrusion ☒ **Loose Brick** ☐ Deteriorated

Infiltration: ☐ None ☐ Joint ☐ Cracks ☐ Mortar ☐ Roots ☒ **Wall**

chimney loose bricks, infiltration along chimney and corbel wall

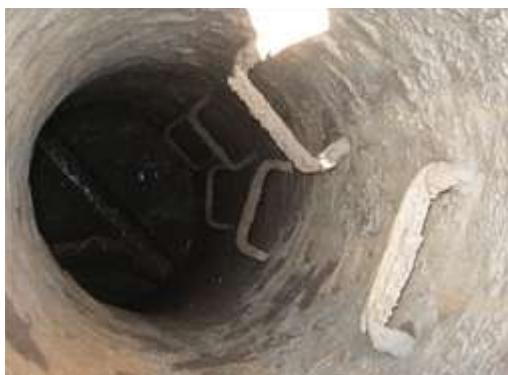
Defect 2

Count: **7** Missing: **0** ☒ **Corroded**

corroded steps, Infiltration at corbel and Barrel

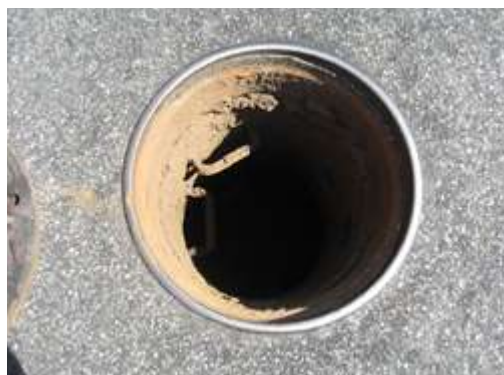
Defect 1

☒ **Leaks**

frame leaks

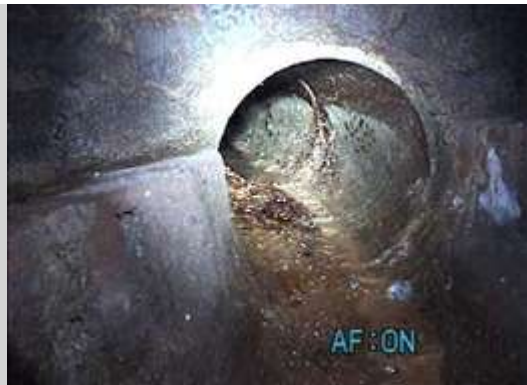
3 O'Clock Inflow

Pipe Height: **8.4** (in.) Rod and Bar (Angled)
Pipe Material: **Clay** ☐ Pipe Lined
Invert Depth: **11.74** (ft.) Flow Characteristics: **Slow**
Deposits: ☐ None ☐ Mud ☒ **Sludge** ☐ Debris ☐ Grease
Silt Depth: **1** (in.) Deposits Extent: **Light**
Infiltration: **None** Pipe Seal Cond: **Sound**
